Leadless pacemaker with acute but transient elevation of lead impedance and pacing threshold

To appear in: *CJC Open*

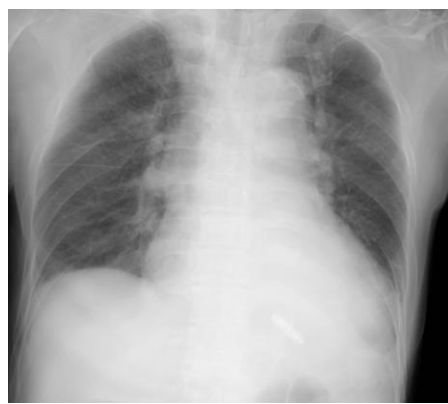
A Post LPM implantation

154 **A:** Posterior-anterior chest radiograph. **B:** Lateral chest radiograph showing the position of
155 the final implant attempt. **C:** Posterior-anterior chest radiograph. **D:** Lateral chest radiograph
156 showing the position of a leadless pacemaker 3 days after implantation. **E:** Right anterior
157 oblique view and **F:** left anterior oblique view showing the position of the final implant
158 attempt. The temporary pacing lead and telemetry are shown. **G:** Right anterior oblique view
159 and **H:** left anterior oblique view showing the position of the leadless pacemaker 3 days after
160 implantation.

53 threshold of 4.61 V at 1.0 ms. The electrical parameters did not change in sitting and lying positions.
54 Automatic electrode impedance measurement on the third day after LPM implantation was
55 about 500 Ω . Chest radiography and fluoroscopic imaging showed stable device location in
56 the right ventricle, similar to the intraprocedural location (**Fig. 1**). Fluoroscopic imaging also
57 showed the swinging movement of the LPM. Reimplantation of the LPM was scheduled.
58 However, the next day, manually measured electrical parameters showed a sensed R wave of
59 3.5 mV, pacing impedance of 400 Ω , and pacing threshold of 1.5 V at 0.4 ms. Automatic
60 electrode impedance measurement at 2:30 AM on day 4 after LPM implantation was about
61 400 Ω , which was an acceptable level of impedance. The patient did not receive any oral
62 anticoagulation therapy. We monitored the electrical parameters remotely without any further
